LACKAWAXEN RIVER BASIN  
LACKAWAXEN RIVER, PENNSYLVANIA

## PROMPTON LAKE

CONDITION REPORT  
DAM, OUTLET WORKS & SPILLWAY  
PERIODIC INSPECTION REPORT NO. 2

NOVEMBER 1971

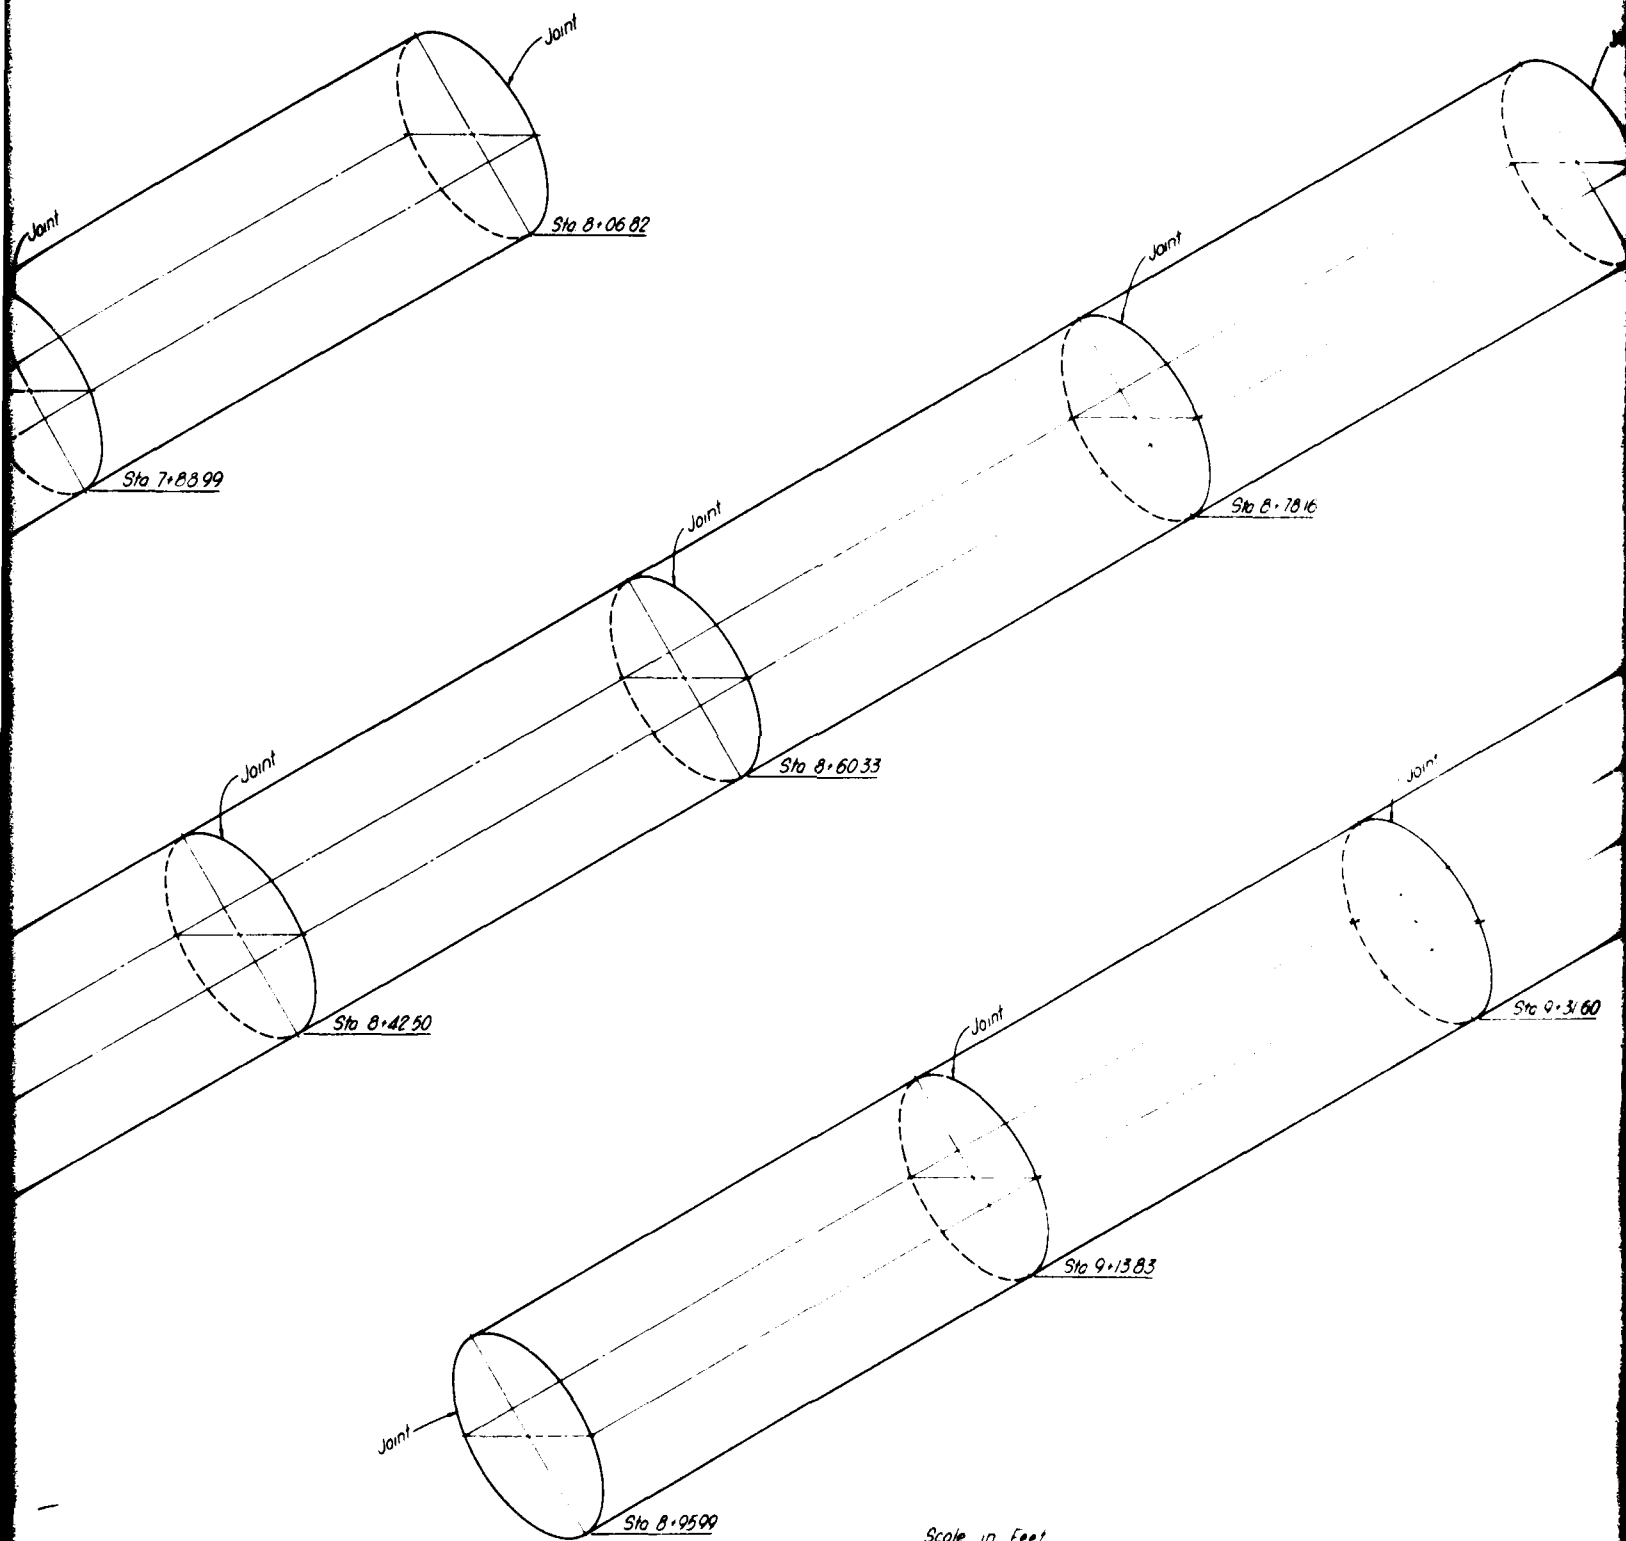
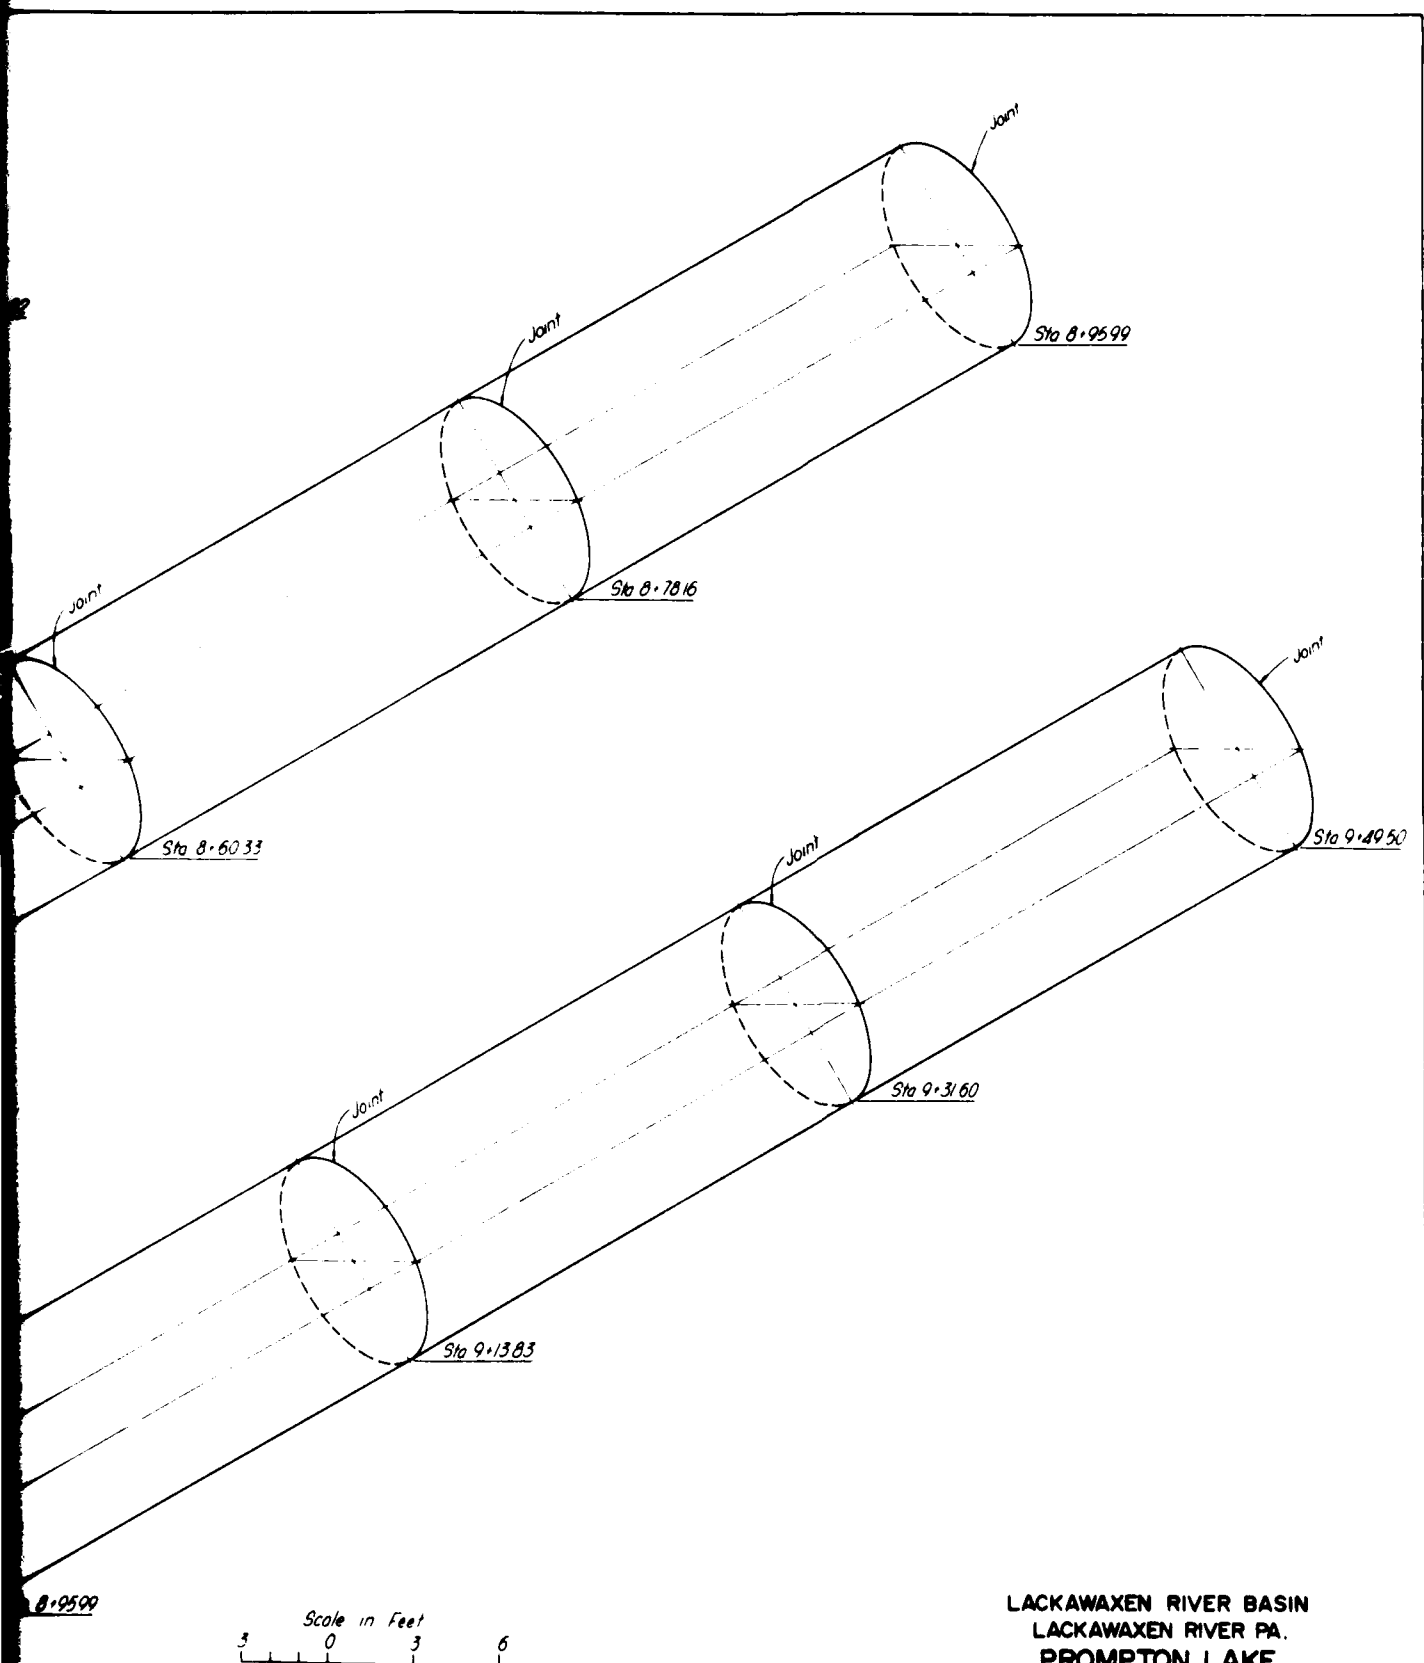
LACKAWAXEN RIVER BASIN  
 LACKAWAXEN RIVER PA.  
 PROMPTON LAKE  
 CONDUIT CRACK SURVEY  
 STATION 7+35.50-9+49.50

5.3 CONDUIT CONDITION SURVEY. In accordance with paragraph 5.2b(4) above which suggests a condition survey be performed in the Prompton conduit, the survey was made during September 1971 for inclusion into this report. The purpose of the survey was to determine the extent and seriousness of cracking and spalling in the conduit and to document present conditions photographically. The photographs appear in Appendix E entitled "Conduit Condition Survey." It is noteworthy that although Prompton Lake conduit was founded on an unconsolidated overburden glacial-derived material approximately 140 feet deep in the valley section, only one crack of any significance was found in the conduit. An isometric view of the conduit showing the relative position of extent of this crack is shown on plate 11. Although no other cracks were found during the condition survey, the remainder of the tunnel is shown in isometric view on plates 10 and 12 for future use in the event more cracking develops.
